Department of Fish and Wildlife

Subject: Central Oregon Irrigation District Siphon Power Project (P – 3571)
Overflow Incident – Observations of the Oregon Department of Fish and Wildlife

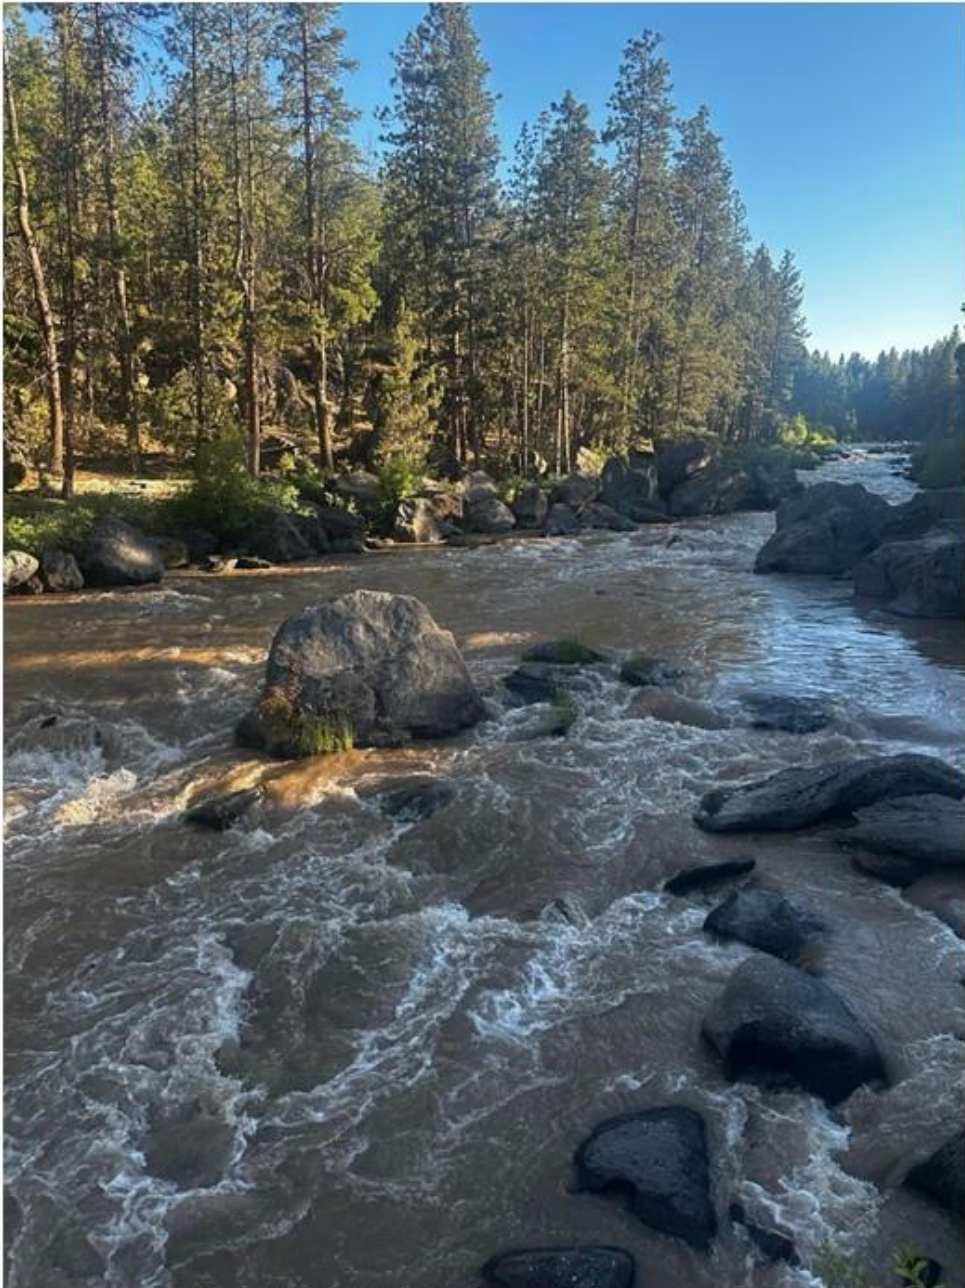
July 5, 2024, Photo Credit: Nick Birdseye

On July 11th, ODFW staff were able to walk the site and locate the overflow areas and scour channels formed by the spilling water. The water was observed to have overtopped the Project forebay in two main areas near the inflow and outflow structures. ODFW surveyed multiple scour channel profiles to estimate the volume of sediment transported to the river. One subsection of a scour channel surveyed measuring 88 yards long, was estimated to have a volume of 99 cubic yards. As this was only one of many drainage paths taken by the spilled water, the amount of sediment that entered the river is unknown. The sediment and debris that had been carried downhill contained a large amount of pumice. A portion of the Project access road and recreation trail were also observed to have been impacted, with repairs already having been made.

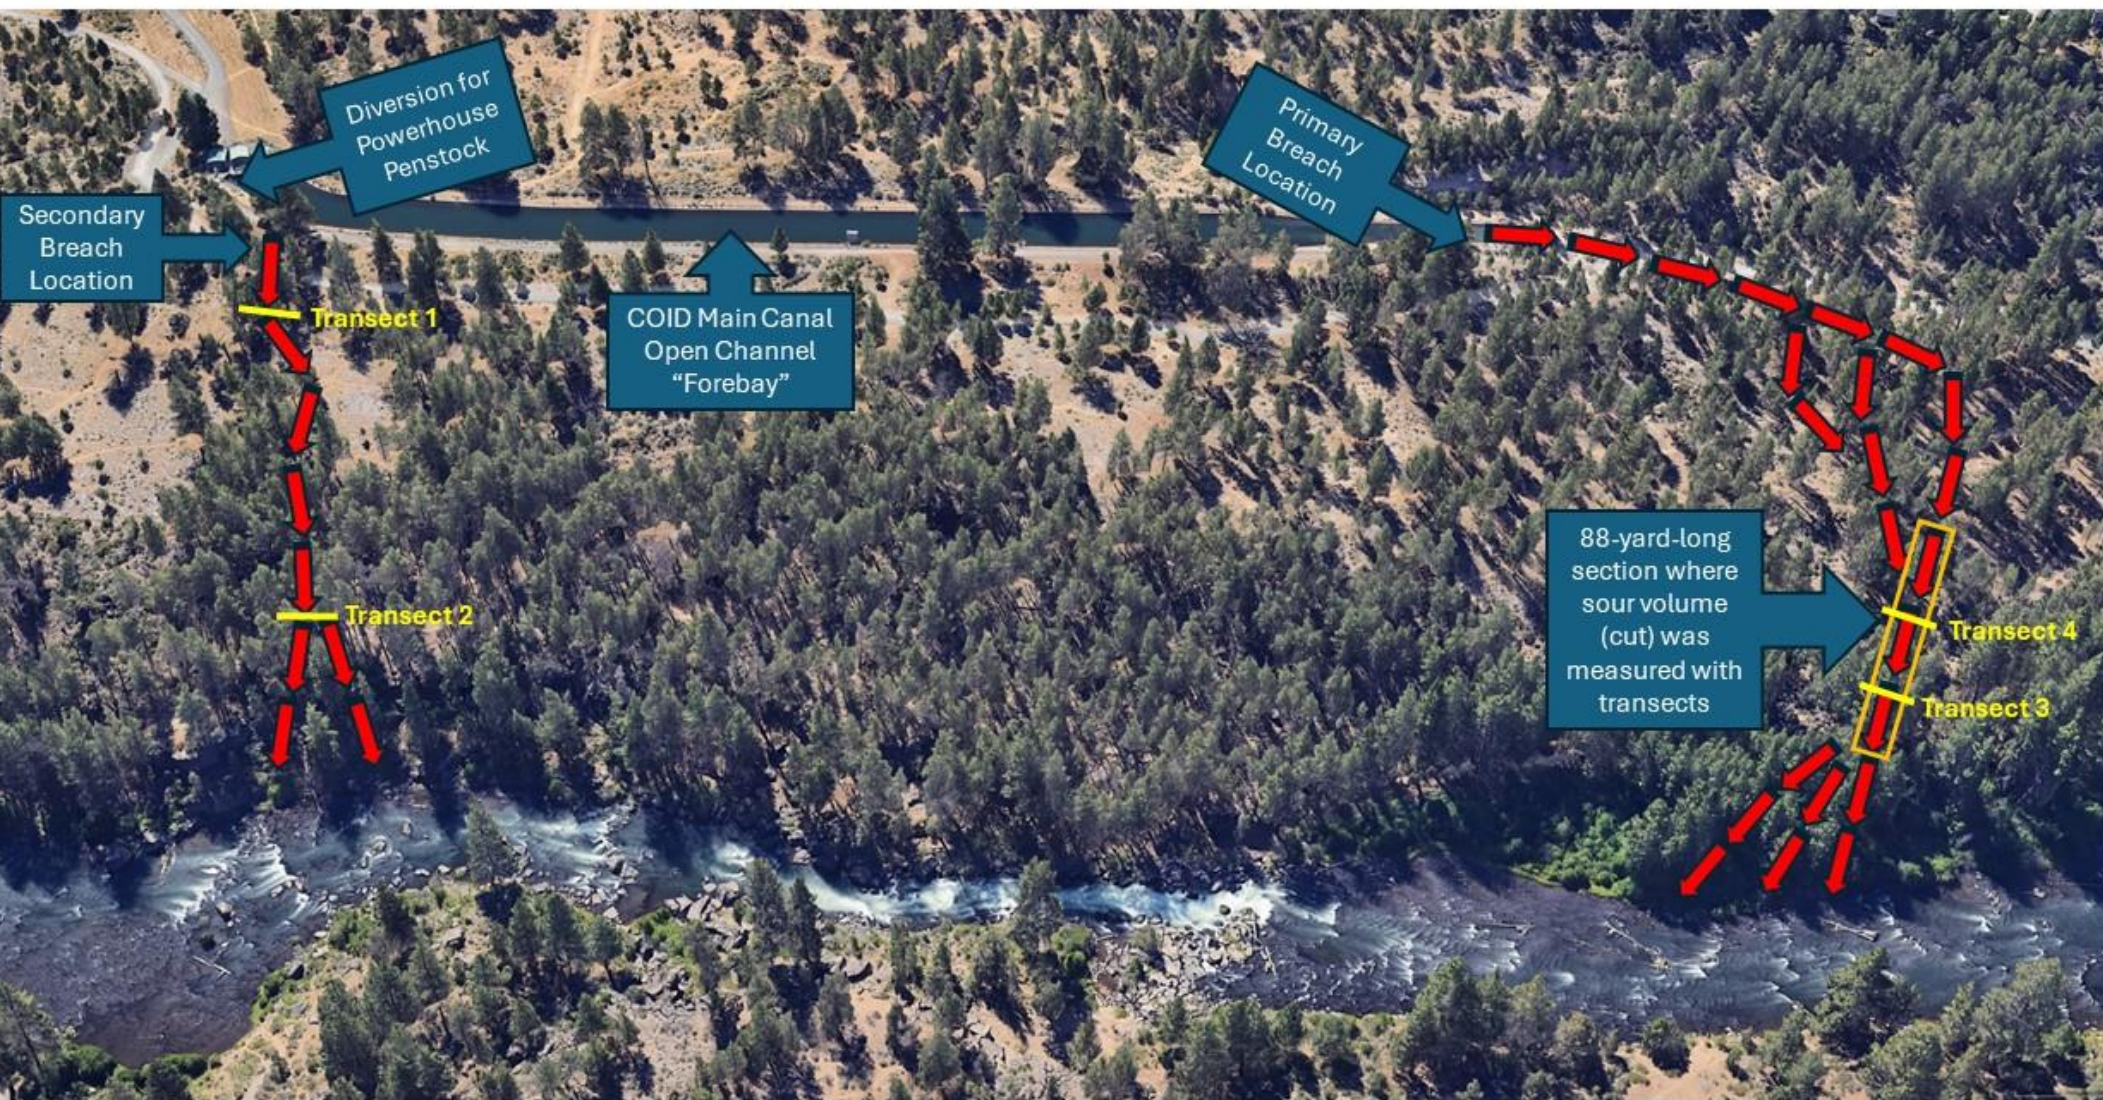
Observed overflow areas and approximate flow paths of sediment. Transect locations in yellow.

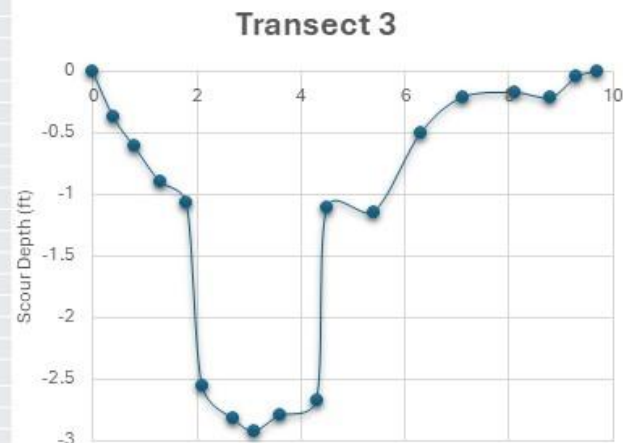
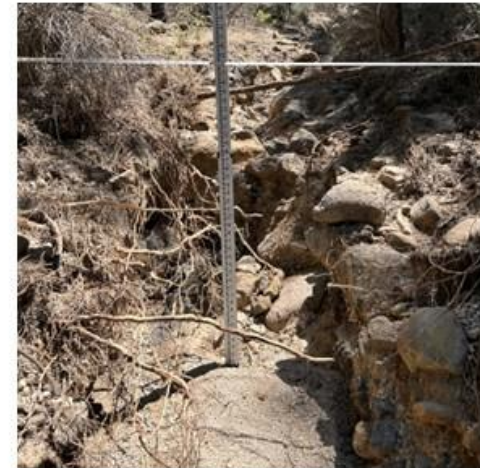
Transect 3					
Lat	44.029988	Long	-121.33535		
Station (ft)	Distance	Height to tape (ft)	Depth (ft)	Trapezoid	Notes
1.1	0	0.93	0		0.074 Top of scour line
1.5	0.4	1.3	-0.37		0.196 scour
1.9	0.8	1.54	-0.61		0.3775 scour
2.4	1.3	1.83	-0.9		0.4925 scour
2.9	1.8	2	-1.07		0.543 scour
3.2	2.1	3.48	-2.55		1.611 scour, deep rut
3.8	2.7	3.75	-2.82		1.148 scour, deep rut
4.2	3.1	3.85	-2.92		1.4275 scour, deep rut
4.7	3.6	3.72	-2.79		1.911 scour, deep rut
5.4	4.3	3.6	-2.67		0.378 scour, deep rut
5.6	4.5	2.04	-1.11		1.0125 scour
6.5	5.4	2.07	-1.14		0.738 scour
7.4	6.3	1.43	-0.5		0.284 scour
8.2	7.1	1.14	-0.21		0.19 scour
9.2	8.1	1.1	-0.17		0.133 scour
9.9	8.8	1.14	-0.21		0.0625 scour
10.4	9.3	0.97	-0.04		0.008 scour
10.8	9.7	0.92	0		Top of scour line
Area	10.5865Sq Ft				
Area	1.1762Sq Yards

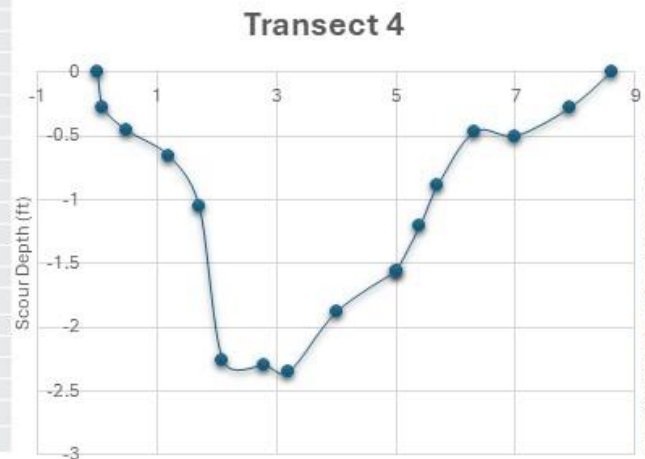
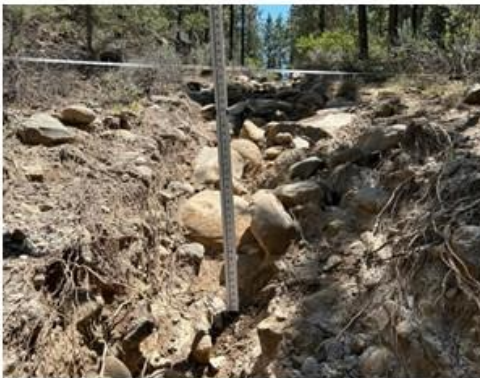
Transect 4					
Lat	44.02944	Long	-121.335307		
Station (ft)	Distance	Height to tape (ft)	Depth (ft)	Trapezoid	Notes
1.1	0	0.8	0		0.014 Top of scour line
1.2	0.1	1.08	-0.28		0.148 scour
1.6	0.5	1.26	-0.46		0.392 scour
2.3	1.2	1.46	-0.66		0.4275 scour
2.8	1.7	1.85	-1.05		0.662 scour
3.2	2.1	3.06	-2.26		1.596 scour, deep rut
3.9	2.8	3.1	-2.3		0.93 scour, deep rut
4.3	3.2	3.15	-2.35		1.692 scour, deep rut
5.1	4	2.68	-1.88		1.72 scour, deep rut
6.1	5	2.36	-1.56		0 scour, deep rut
6.1	5	2.36	-1.56		0.552 scour
6.5	5.4	2	-1.2		0.312 scour
6.8	5.7	1.68	-0.88		0.405 scour
7.4	6.3	1.27	-0.47		0.3395 scour
8.1	7	1.3	-0.5		0.351 scour
9	7.9	1.08	-0.28		0.098 scour
9.7	8.6	0.8	0		Top of scour line
Area	9.639Sq Ft				
Area	1.071Sq Yards

Estimated scour volume of 88-yard section at 99 cubic yards.
