INGRAM MEADOW RESTORATION & NORTH GRIZZLY HABITAT ENHANCEMENT PROJECT Project Completion Report

Location: Ochoco National Forest – Lookout Mountain Ranger District, Crook County, Oregon

Field Completion Date: 10/30/2020

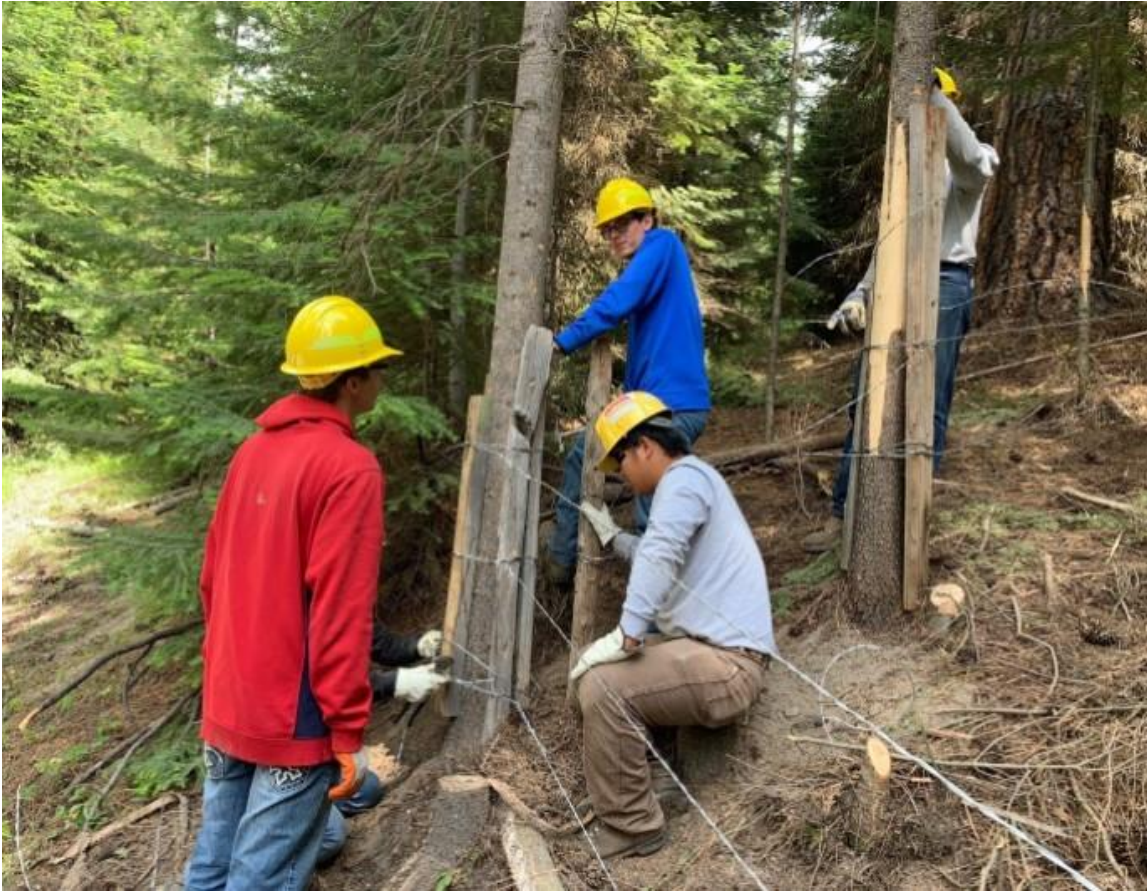
Figure 1: Members of the Youth Conservation Corps reconstruct wildlife-friendly fence around Ingram Spring to prevent degradation from livestock. The spring lies at the bottom of Ingram Meadow and represents a unique and critical habitat for wildlife.

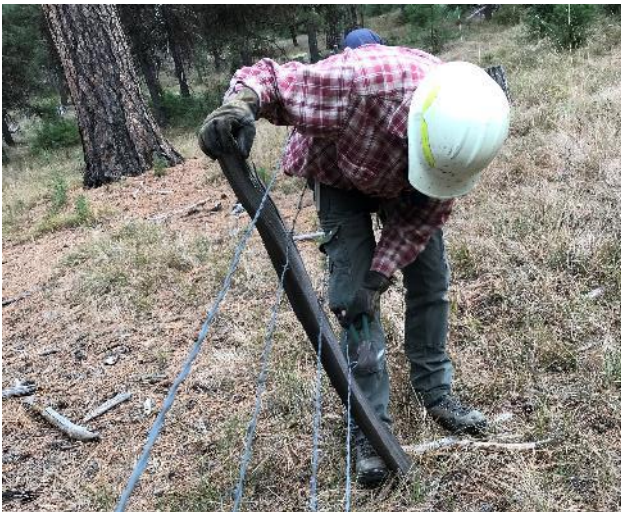
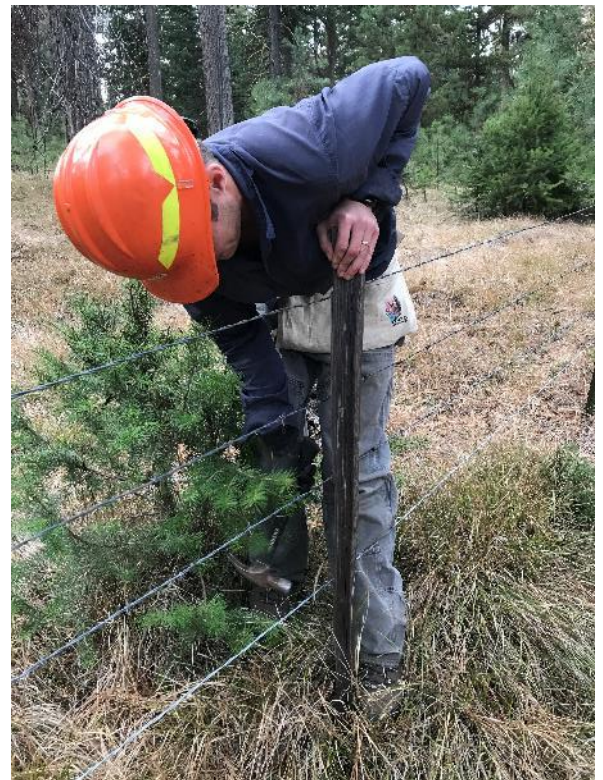
Figures 2 and 3: Existing livestock-exclusion fencing surrounding Ingram Meadow was retrofitted to be wildlife-friendly. Smooth wires on both top and bottom as well as providing the proper spacing and heights ensured that wildlife passage into and out of the restoration area would be safe and free from harmful barriers.

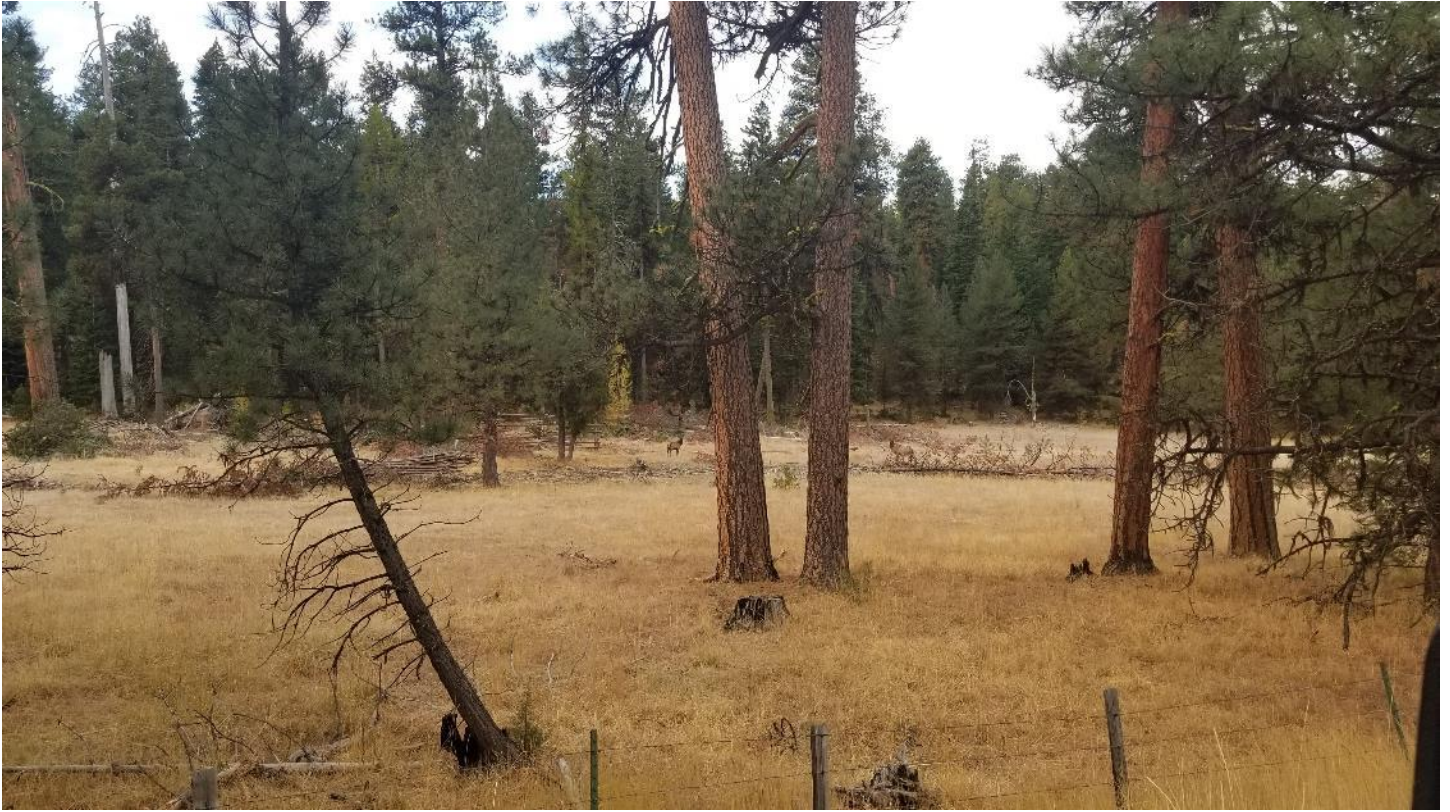
Figure 4: Autumn in Ingram Meadow. Along with enhancing the fence around the meadow, multiple activities were conducted to improve various aspects of the habitat within the meadow itself. Wildlife use of this meadow was abundant, even during implementation, as can be seen by the multiple elk pictured within the meadow near the part-way completed buck and pole fence.

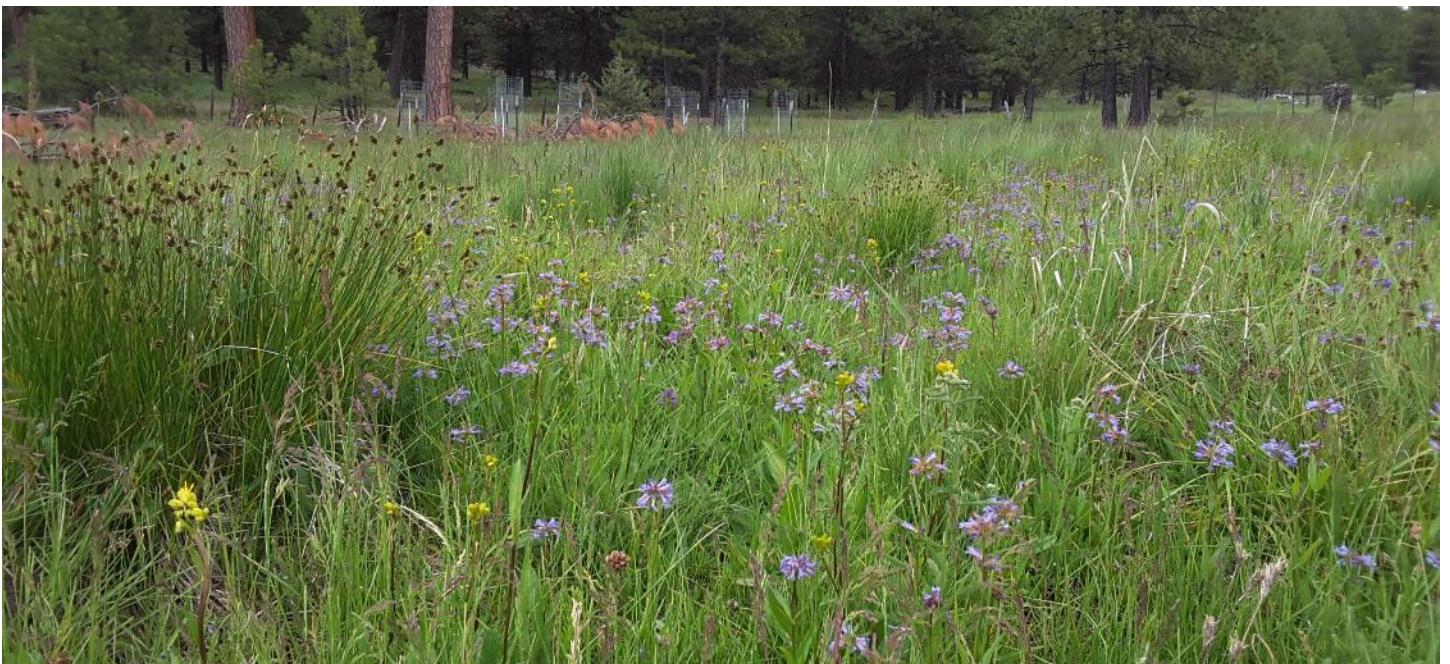
Figure 5: Wildflowers and bumble bees dot the landscape in late spring in Ingram Meadow. In the background you can see the recently planted hardwoods lie protected within their individual cages.

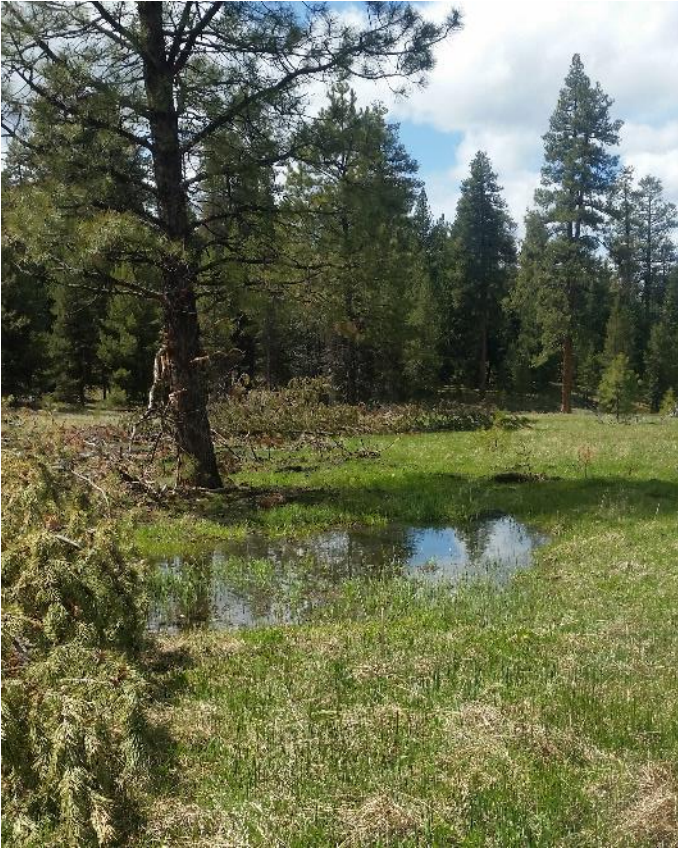
Figure 6: Thinning slash and debris along with fill material such as soil and rock were placed inside the channel to slow the water flow and cause it to saturate the meadow during high seasonal flows.

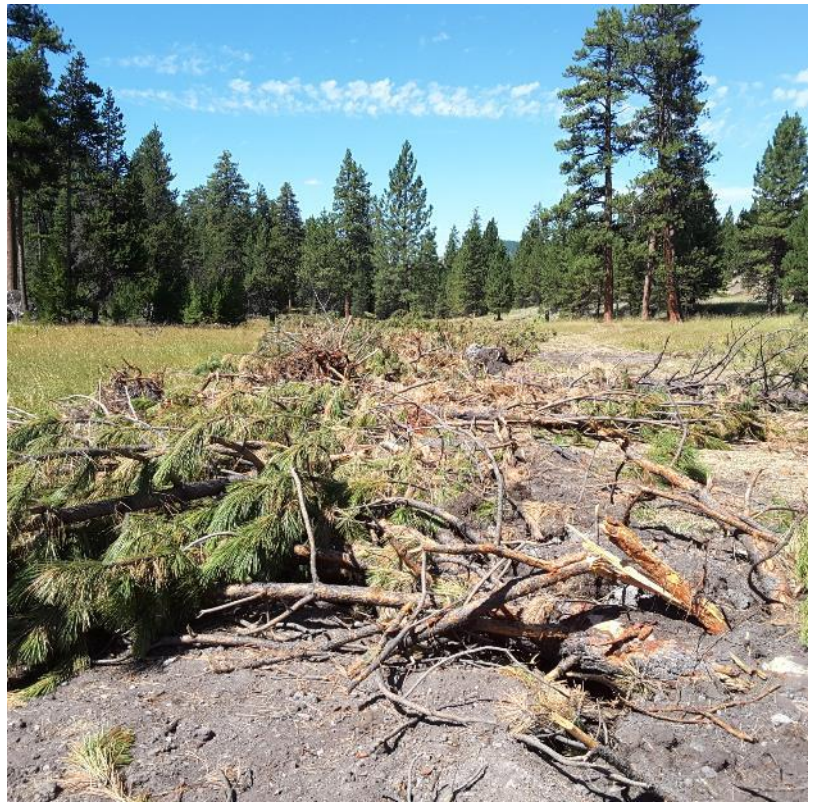
Figure 7: After implementation, surface water was present in various small ponds and across the large meadow expanse radiating outward from where the original 2-foot wide channel had been.

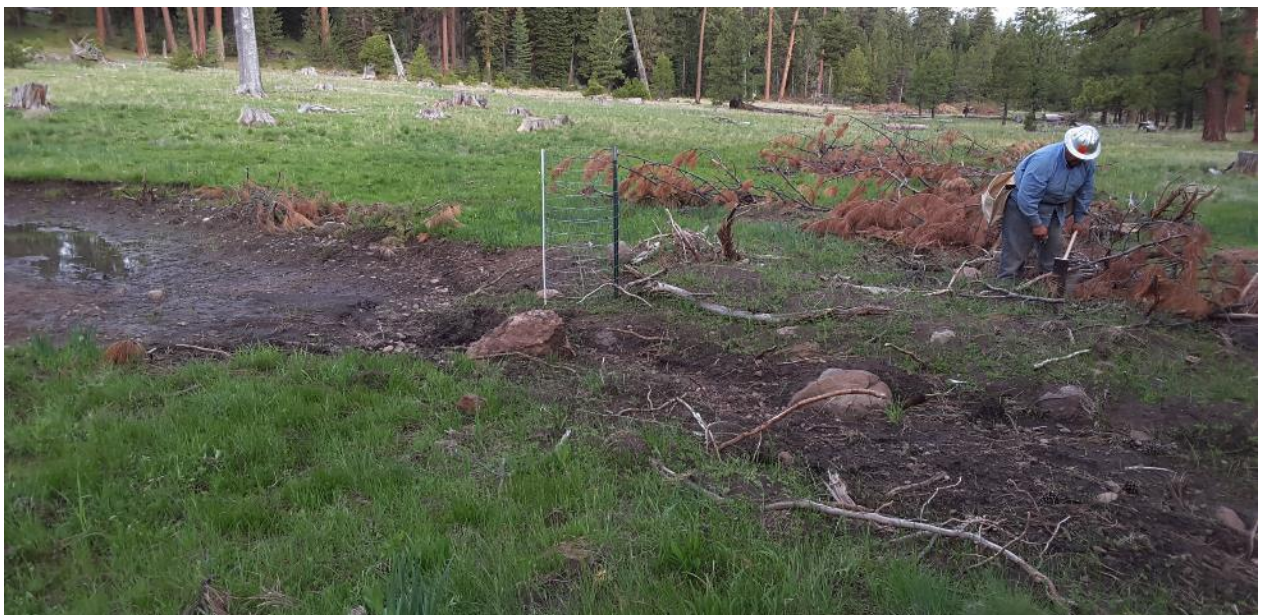
Figure 8: Riparian plants were planted and caged within the meadow restoration along the newly saturated areas. Numerous shallow pools and pits were created to help provide additional surface water to wildlife throughout the year.

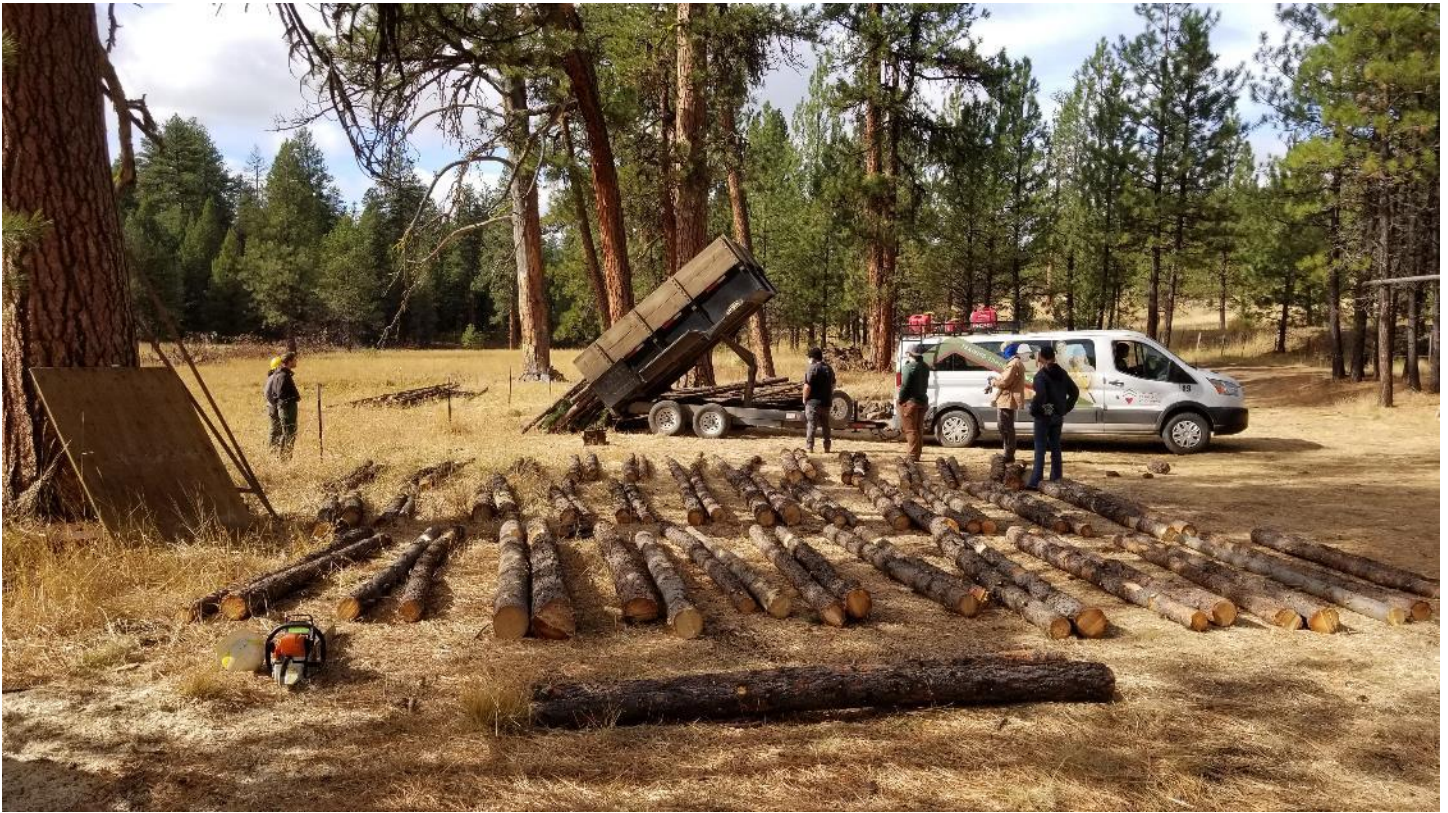
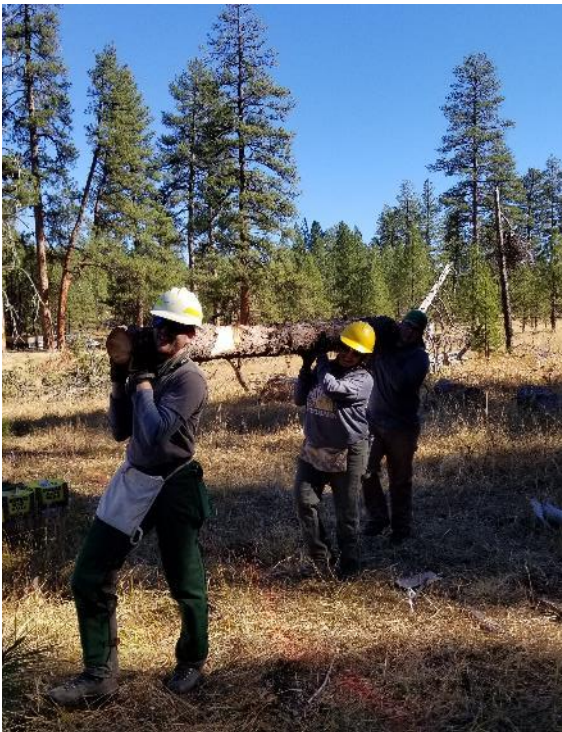
Figures 9, 10, and 11: Members of the Heart of Oregon – AmeriCorps group assisted the U.S. Forest Service in construction of a half-acre buck and pole fence that excluded wildlife from a portion of the meadow that had some existing hardwoods which were heavily browsed as well as newly transplanted aspen and other hardwoods as part of the restoration efforts. Materials were sourced from onsite, using conifers encroaching into the meadow as the fence poles and rails.

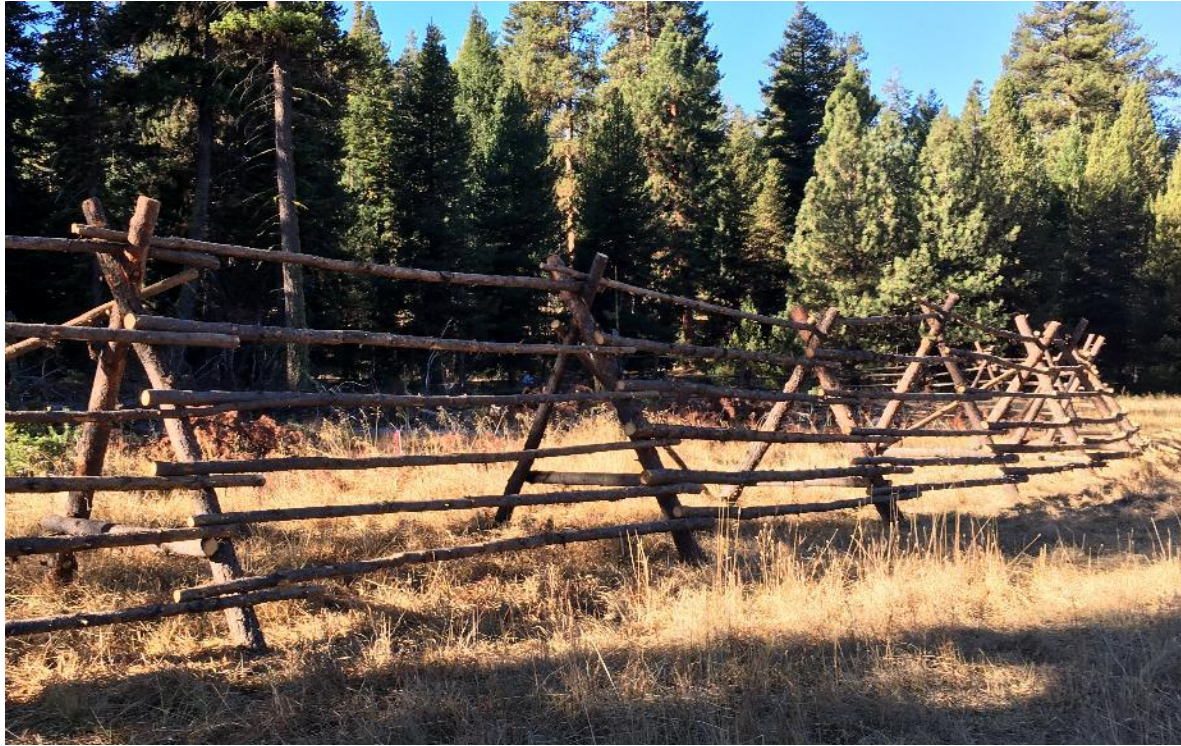
Figure 12: This 8-foot-high, three-dimensional, fence will assist and accelerate the growth of hardwoods at this site, by excluding big game species. However, due to use of natural materials, this fence will be allowed to deteriorate over time at which point, it will once again allow for big game use giving the hardwoods sufficient time to recover and or establish.

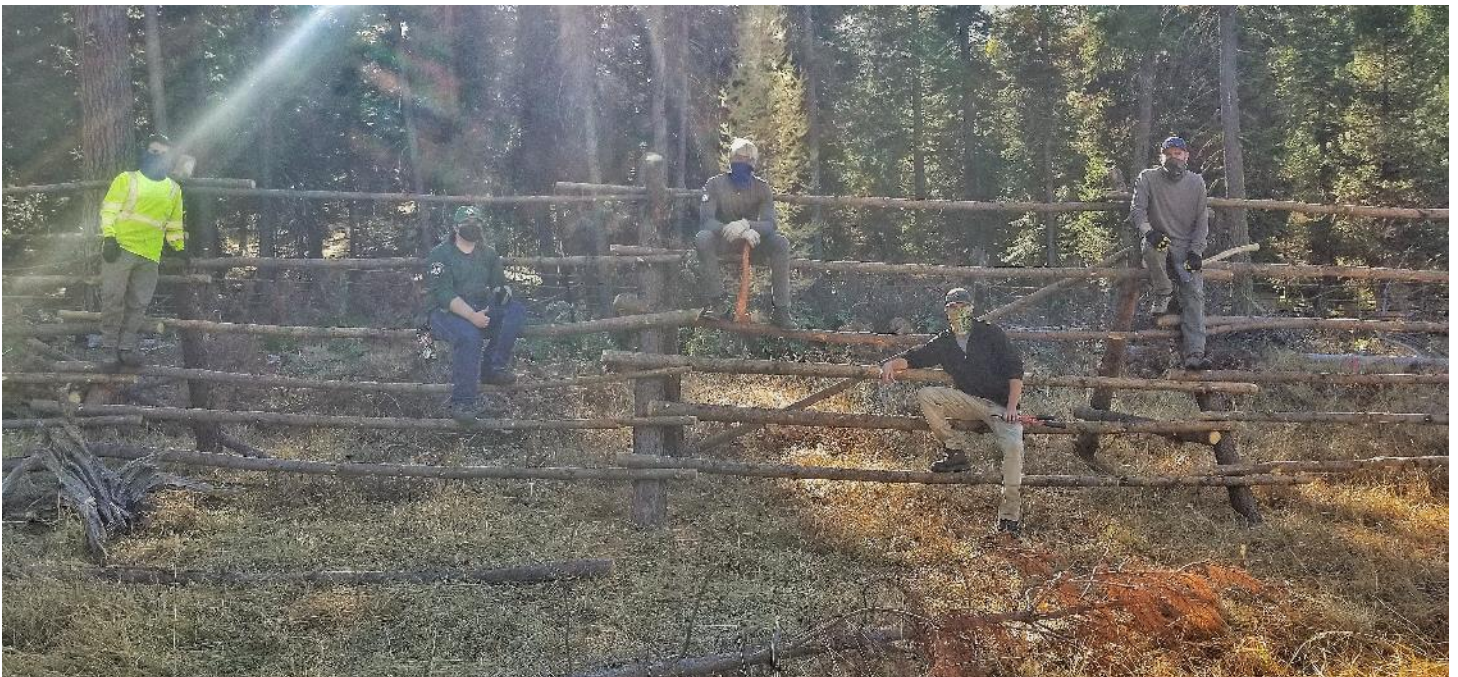
Figure 14: Just down the road from Ingram Meadow lies a well-established 5-acre aspen stand associated with an additional spring near Rooster Rock. Encroaching conifers were competing with young sprouts for nutrients and sunlight, so to reduce this competition conifers were fell within 100 feet of an aspen sprout. In areas where the trees could not be safely cut, they were girdled to reduce competition and also provide variability for wildlife habitat.

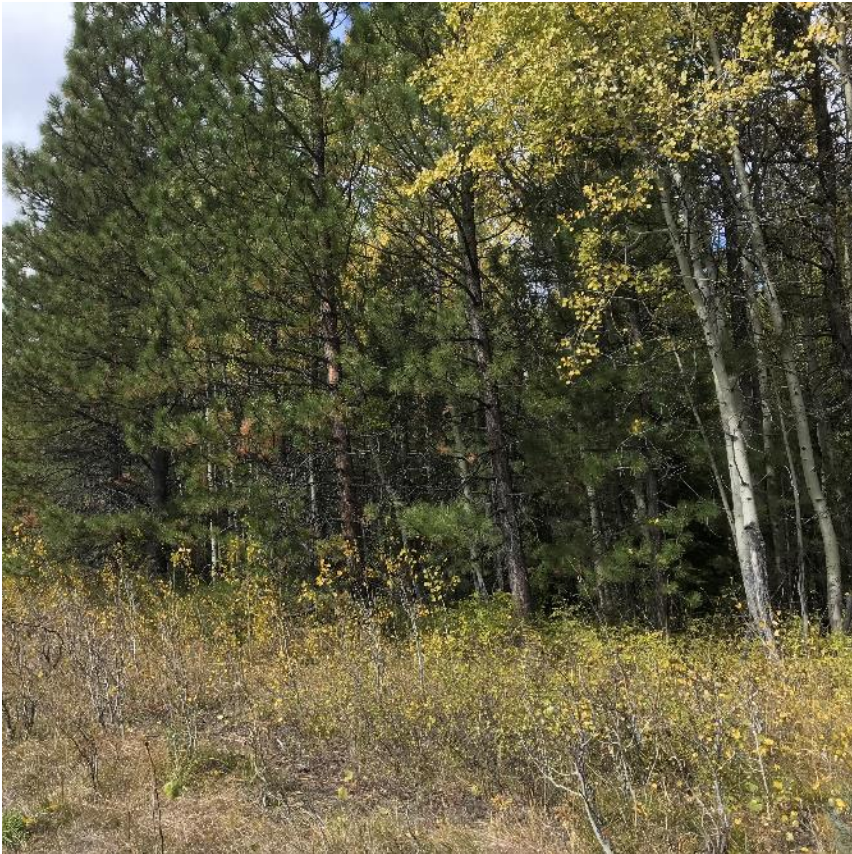
Figures 15 and 16: Before and after photos of the conifer felling within Rooster Rock. On the left you can see all the young aspen sprouts in the foreground and on the right, you can see the felled trees and slash placed around them to protect the sprouts from browsing by livestock and wildlife while they mature.

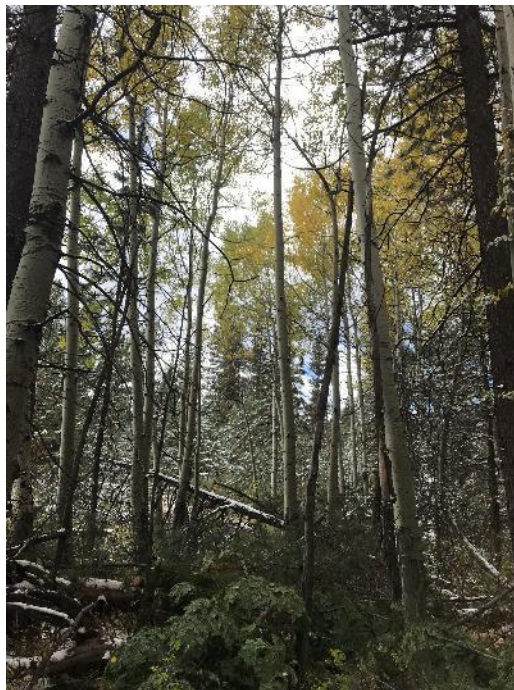
Figures 17 and 18: Aspen was released along three of the four edges, as well as within the interior of the stand. Small patches of fir consisting of a few large diameter trees were left for habitat diversity and cover across the five-acre stand.

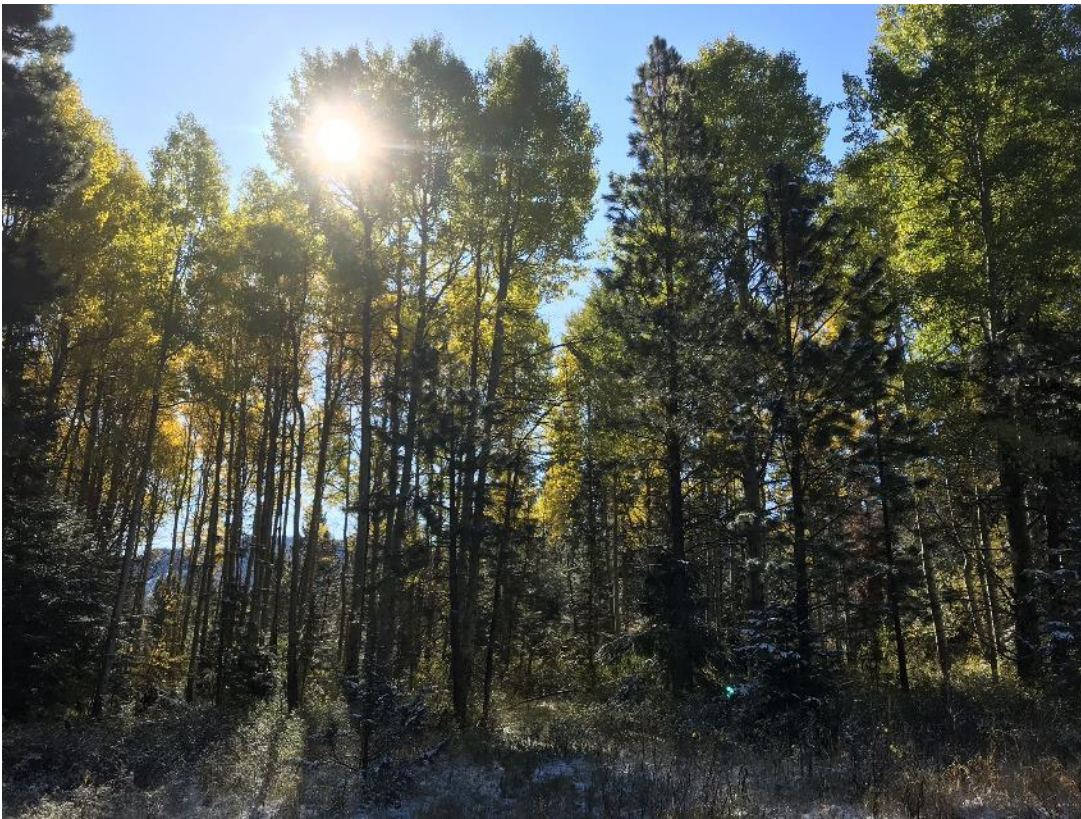
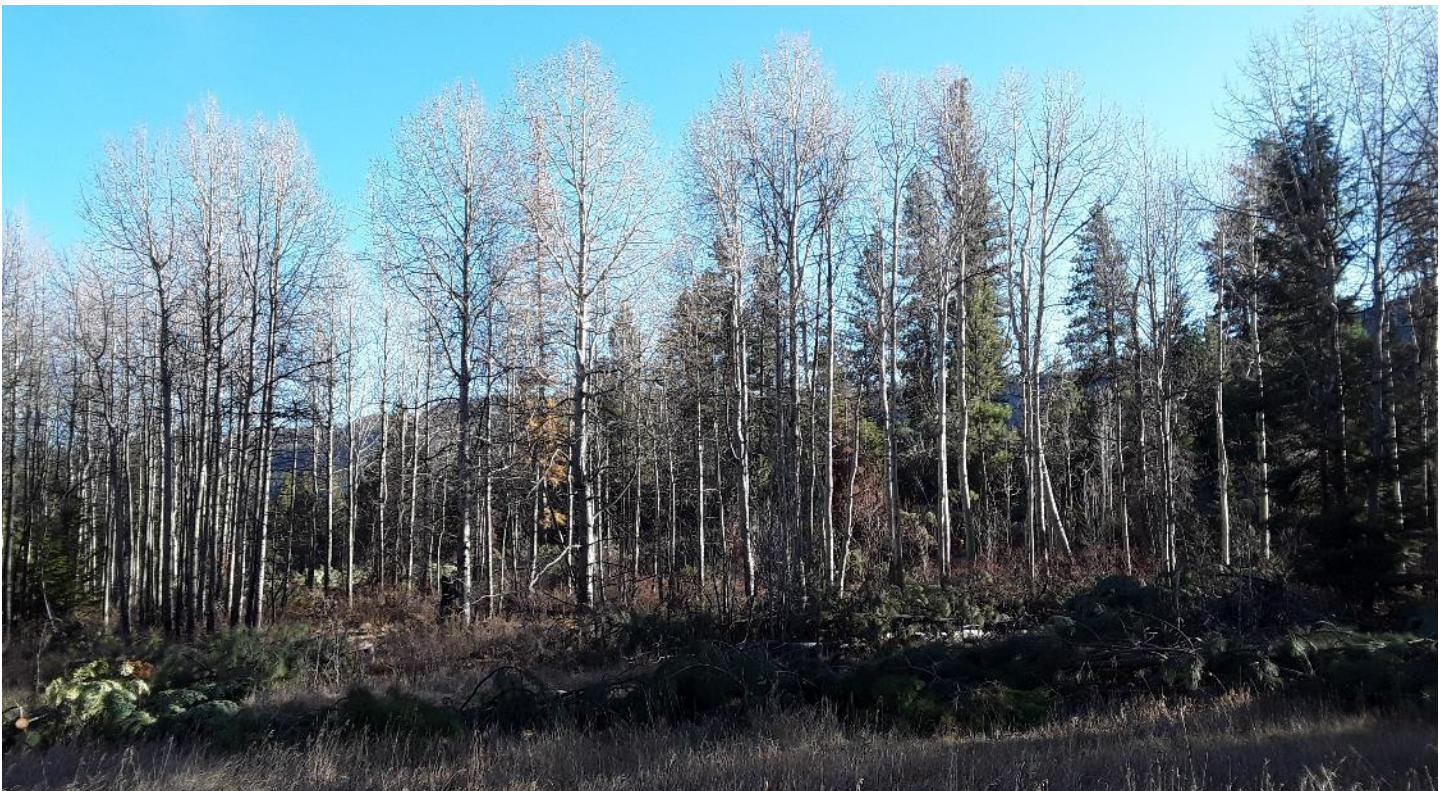
Figures 19 and 20: Photos of before and after treatment of a section of the Rooster Rock aspen stand. In the first photo aspen and fir co-dominate the canopy, while in the second photo aspen is the dominant species and the multi-aged stand of fir is almost non-existent save for a few large diameter trees. Sunlight is now able to pass through the entire width of the stand which should allow for expedited growth of sprouts on both sides.

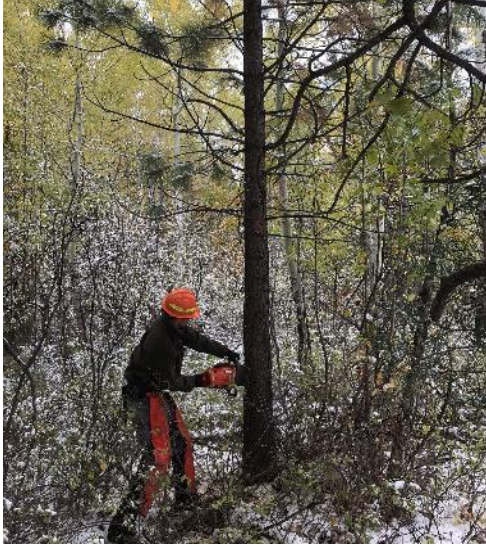
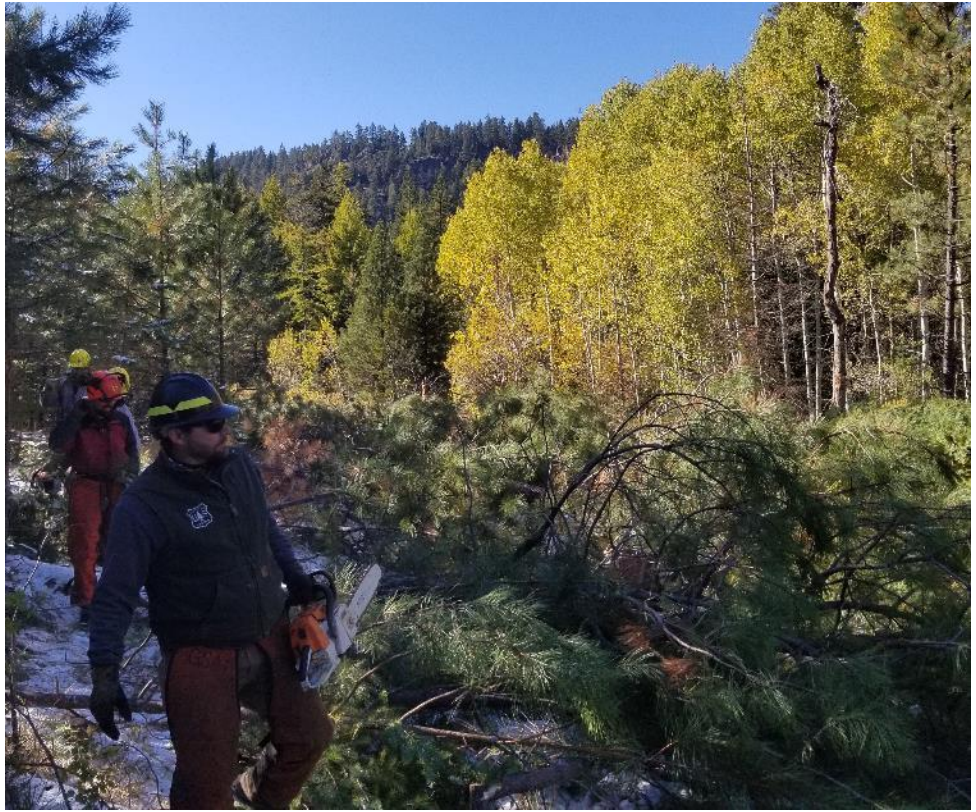
Figure 23: In order to reduce browsing on the aspen sprouts and to reduce pressure from livestock, efforts were made to directionally fell conifers to provide some protection around young trees. In addition, the existing buck and pole fence around the stand was improved by adding thinning slash, creating a temporary barrier that will reduce, but not eliminate, use of certain parts of the stand.

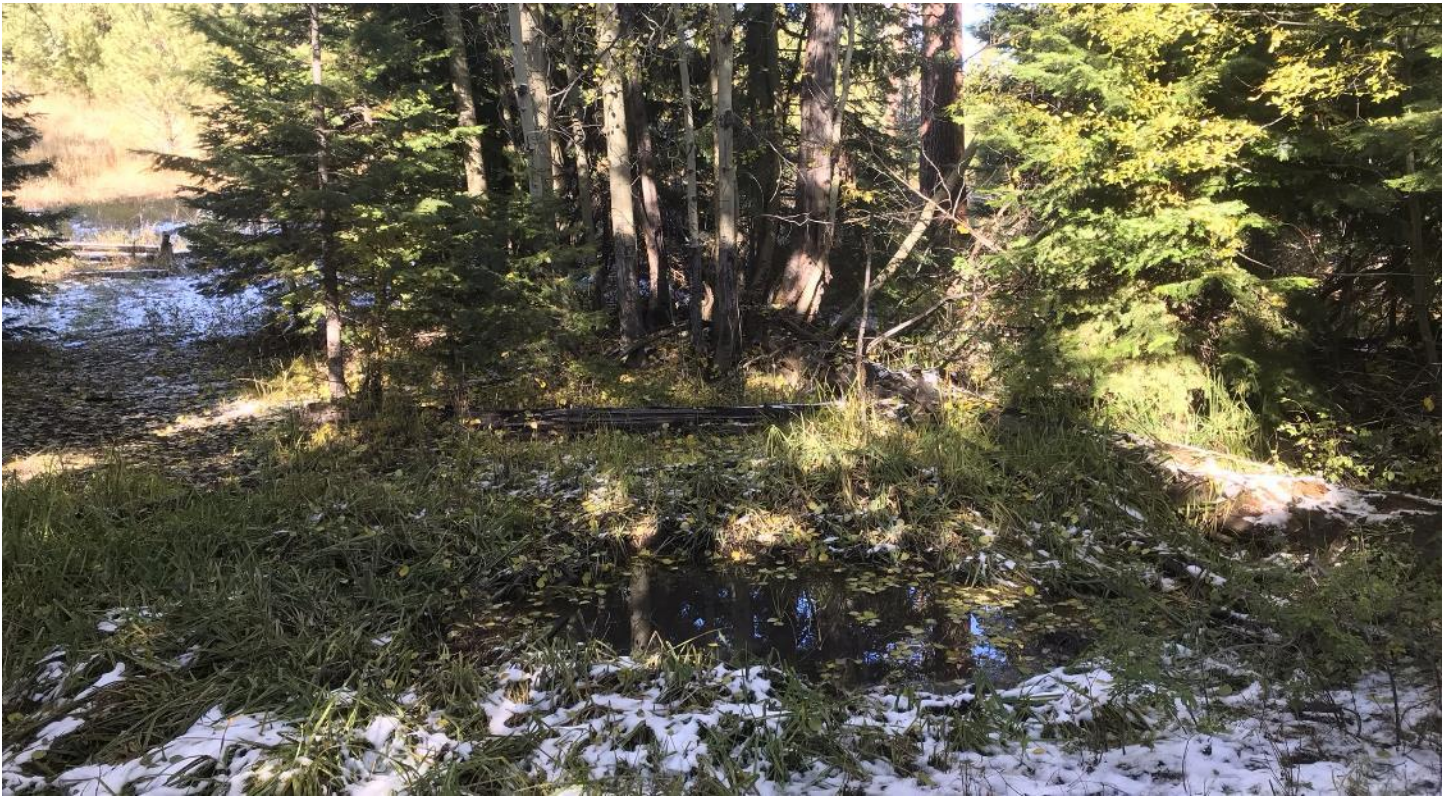
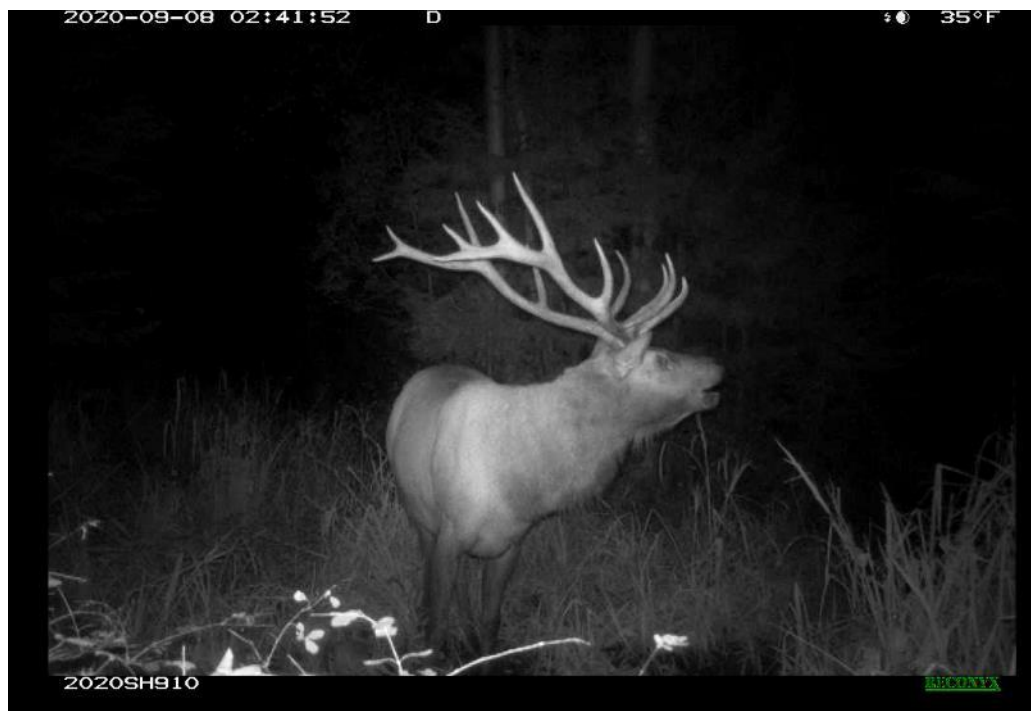
Figures 24 and 25: At one end of the aspen stand lies a spring, which also includes a well-defined path through the stand, bisected by a wallow. This area was left untouched to provide habitat characteristics conducive for its use by wildlife. After implementation a remote sensor game camera was placed and a bull elk bugling at the wallow was captured on video indicating use of the area by elk is still occurring.

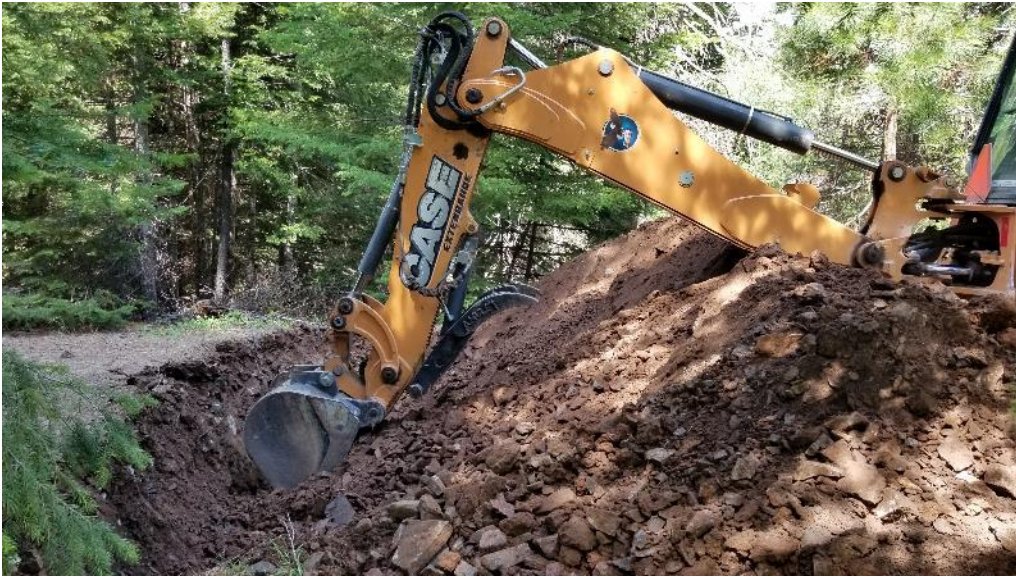
Figure 26: Throughout the northern portions of the Grizzly Wildlife Management Unit over 20 miles of roads were physically closed to provide additional security habitat for big game in an effort to ensure deer and elk are maintained on public land. These closures represented approximately 1,300 acres of habitat improvement for big game. Pictured here is the construction of a berm which was utilized as part of an “entrance treatment” which

consisted of a berm, placement of slash, debris, and/or boulders, and disguising the road bed for a sight distance to deter unauthorized motor vehicle use.

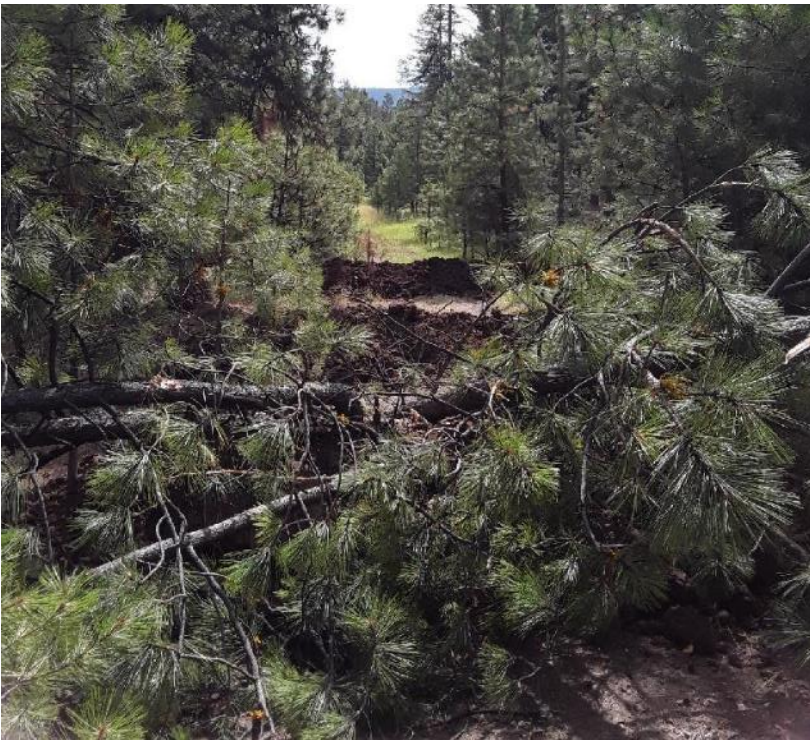
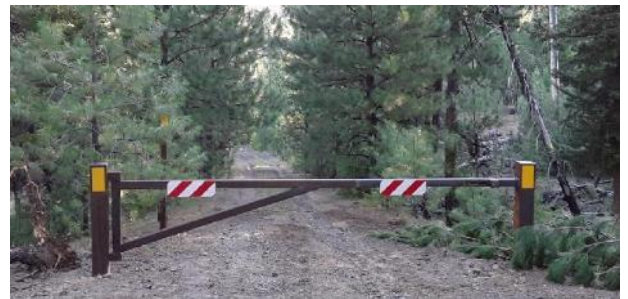
Figures 27 and 28: Multiple tactics were utilized to reduce and prevent unauthorized motor vehicle use of closed roads within the project area. Pictured here are examples of multiple berms, and the placement of slash, debris, and boulders to secure the physical closures. In addition, two gates were placed on the landscape to allow for continued, but infrequent, administrative access when needed.
